Seismic Evaluation and Retrofit of the Ataturk International Airport Terminal Building

by Michael C. Constantinou, Andrew S. Whittaker and Emmanuel Velivasakis

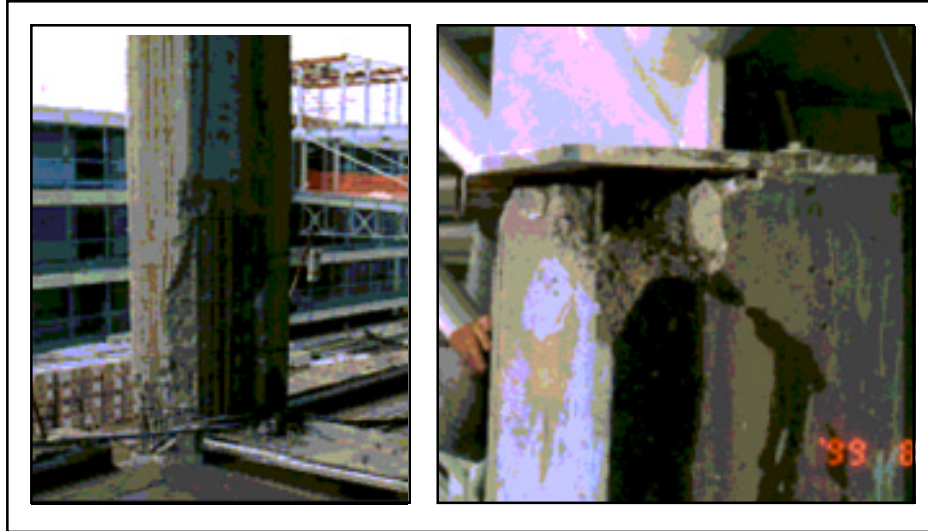
acceleration was less than 0.05g. Investigations by LZA engineers immediately following the earthquake identified damage to parts of the building, including spalling of the cover concrete and buckling of the longitudinal rebar at the base of the third story columns (showing also lap splices and little transverse rebar in the hinge zones), loss of concrete at the underside of the roof truss-cantilever column connections and slippage of the roof-truss baseplates atop the columns,

■ **Figure 3.** Observed Damage to the Terminal Building; base of third story column (left) and base of roof truss connection to column (right)

and splitting cracks and spalled concrete in the beam-column joints at the third floor level (indicating no transverse reinforcement in the joints). Photographs of damage to the building are shown in Figure 3.

This scheme selected for the retrofit (or upgrade) of the Terminal building involved the isolation of the roof trusses to reduce the demand on the third story columns and the framing at the lower levels, the addition of shock transmission units to the roof trusses to lock the space-frame truss pods together during earthquake shaking so that the space frame would act as a diaphragm, and selected retrofit and strengthening of the reinforced concrete construction as summarized below.

further strengthen the columns. The objective of such strengthening was to eliminate the weak column-strong beam framing. These columns and the modestly strengthened interior square columns were then jacketed with circular steel casings to substantially increase the shear strength of all the columns and to provide confinement in potential hinge regions. Such column strengthening was implemented in the second and third stories. In addition, the expansion joints between the pods at the second and third floor levels were eliminated by tying the pods together with reinforced concrete components to substantially increase the redundancy of the lateral-force-resisting system. No beams at either the second or third floors were strengthened.

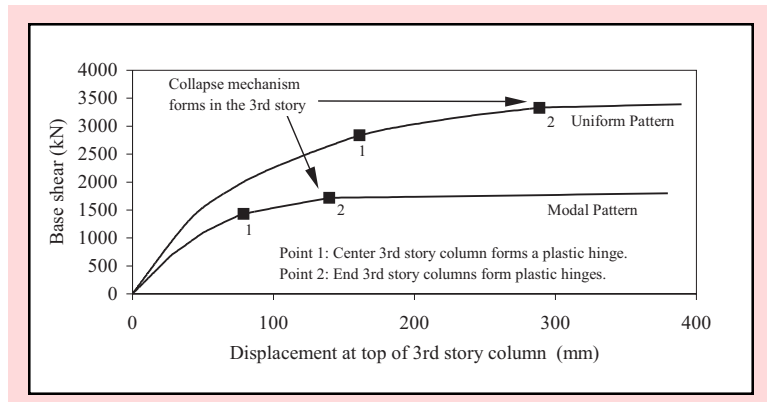
The pushover analysis was accomplished using IDARC 4.0 (Valles et al., 1996). The existing building was analyzed using two lateral-load profiles; second-order effects were automatically included. For this frame, both a uniform pattern and a modal pattern were used. The collapse mechanism involved hinging of the third story cantilever columns for both loading profiles. Figure 4 presents the base shear-roof displacement relationships for the two lateral-load profiles. The significant difference between the two curves is due to the large differences between the weights at the roof and lower levels and the resulting differences between the loading profiles. Nearly all of the building deformation occurs in the third story of the building with the modal load pattern and the framing below the third story does not yield. Such a distribution of predicted damage is completely consistent with the observed damage

■ Figure 4. Pushover Analysis of a Frame in the Original Building

to the reinforced framing with one exception: the beam-column joint damage was not predicted because these joints were assumed to be rigid for the analysis. For information, the third-story drift corresponding to a plastic rotation of 0.01 radian in the third-story column was 80 mm. Clearly, the deformation capacity of the third-story columns would be exhausted well before the target displacement at the roof level was achieved. Further evaluation of the existing building showed that the moment-resisting frames were undesirable weak column-strong beam frames.

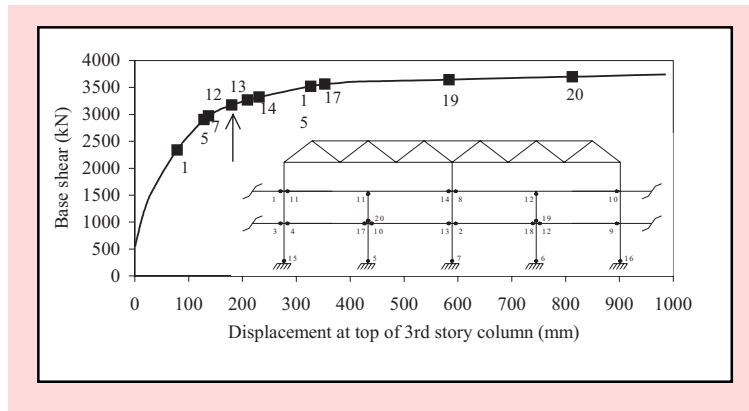
The performance of the retrofitted building was checked by nonlinear static analysis of the frame described above. The resulting pushover curve for the modal load pattern is presented below in Figure 5 together with a sketch showing the sequence of plastic hinge formation (1 through 20). Note that some hinges form simultaneously. For a roof displacement less than 500 mm, hinges form in the beams, at the base of the columns above the foundation, and in the two-story columns at the underside of the third story only.

■ Figure 5. Pushover Analysis of the Retrofitted Frame

the roof level of 190 mm is indicated by the open-ended arrow on the pushover curve of Figure 5. The deformation demands on the beams and columns in the retrofitted building frame at this roof displacement were considered acceptable for the performance level of collapse prevention.

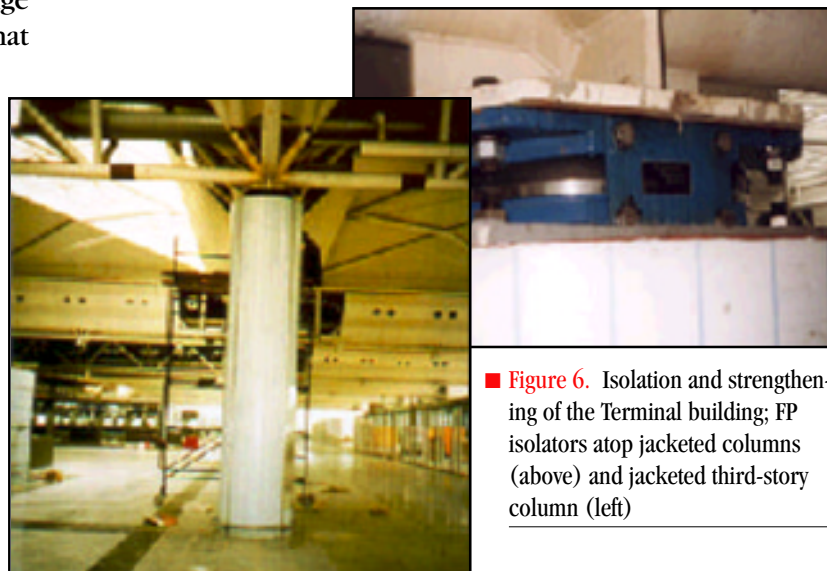
Two photographs of the retrofit work showing an installed FP bearing (before release) and a jacketed column (covered by an architectural treatment) are presented in

■ Figure 6. Isolation and strengthening of the Terminal building; FP isolators atop jacketed columns (above) and jacketed third-story column (left)

Because of architectural constraints, the size of the third story columns could not be increased substantially, so the existing flexural strength of these columns as cantilever elements dictated the inertial force that could be developed at the roof level. Fuses in the form of Friction Pendulum (FP) isolation bearings were used to limit the lateral forces that could be imposed on the third-story columns. (FP bearings were used because such bearings can isolate light components and structures.) Preliminary calculations called for an isolated period of 3.00 seconds (based on the radius of the sliding surface), a design friction coefficient of 0.09, and a displacement capacity of approximately 260 mm.
