Reconstruction of Ica, Pisco, Chincha and Cañete, Peru, Based on Updated Hazard Maps

Julio Kuroiwa

VALIDATION OF THE HAZARD MAPS OF ICA, PISCO, CHINCHA AND CAÑETE

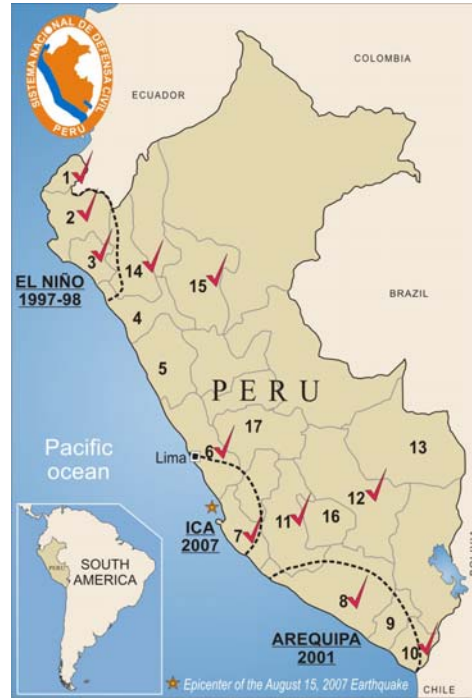
Table 1

Sustainable Cities Program INDECI/UNDP, 1998-2008. Results

From 11/1998 to 06/2008, 133 cities and towns with 6.4 million inhabitants have been investigated. Agreements have been signed with participating local national universities: ✓
 In 10 years some 80 consultants have been trained on the job.

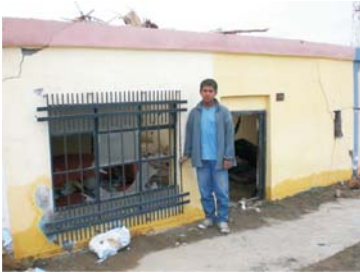
Soil Liquefaction in Tambo de Mora

Settlement of some 2.6 feet (0.8 m)

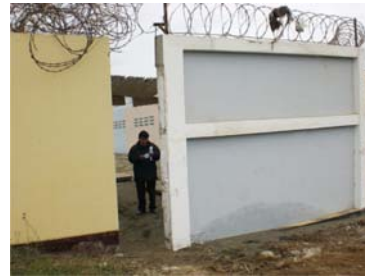
Lateral spread. The right wall has moved to the right and towards the reader, “opening a door”.

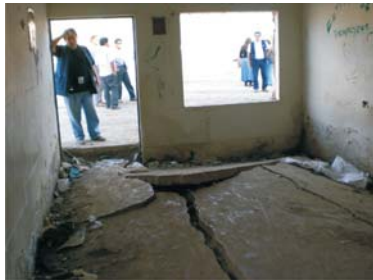
House settlement and floor cracks

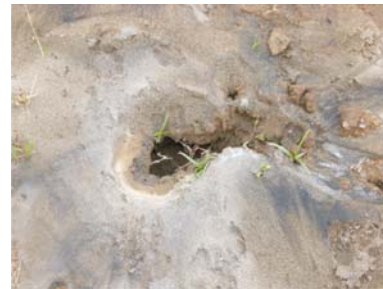
Sand volcano
