MCEER Visits Iceland to Investigate Performance of Seismically-Isolated Bridges

On October 9-10, 2000, Michael Higgins, MCEER's Senior Program Officer for Transportation Research, and Benedikt Halldorsson, Ph.D. candidate in the Department of Civil, Structural and Environmental Engineering at the University at Buffalo, and member of the Student Leadership Council, visited the Earthquake Engineering Research Center, University of Iceland (EERCUI), to review the performance of isolated bridges during two recent earthquakes.

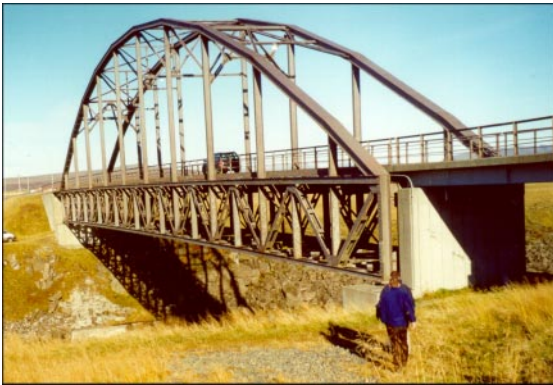
■ The Thjorsa bridge in the South Iceland Lowlands was subjected to a peak ground acceleration of 0.84 g.

One of these bridges, the Thjorsa Bridge, was located 5 km from the June 21st epicenter and only 2 km from the closest surface fault. The bridge consists of three spans: two approach spans with slab on girder construction and one center span consisting of a 270 foot steel truss arch (see photos). Only the center span was isolated. The bridge was instrumented with accelerometers and during the June 21st earthquake, the maximum recorded peak ground acceleration was 0.84 g. It suffered minor permanent displacements in both the lateral and longitudinal directions.

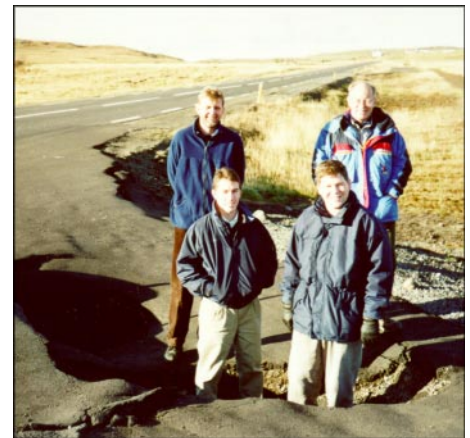
■ The investigative team is pictured standing inside a large surface crack in a parking lot in Skeidar. Front row: M. Higgins and B. Bessason; back row: G.I. Balduinsson and E. Hafliðason.

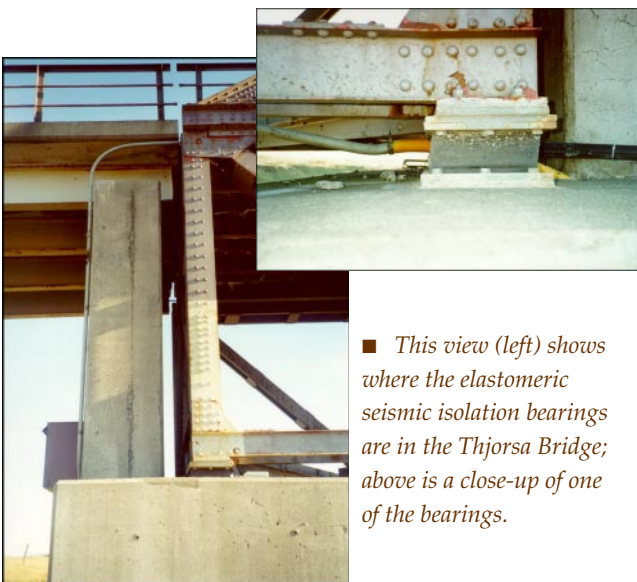
■ This view (left) shows where the elastomeric seismic isolation bearings are in the Thjorsa Bridge; above is a close-up of one of the bearings.
